The “wall-socket” technique. Proposal of a new surgical procedure for revision acetabular arthroplasty

Andrea Emilio Salvi¹, Massimo Pezzoni², Sergio Salvi¹, Pier Angelo Gozzini²

¹ Orthopaedics and Traumatology Department, Mellino Mellini Hospital Trust, Civil Hospital of Iseo (Brescia), Italy; ² Orthopaedics and Traumatology Department, Mellino Mellini Hospital Trust, Civil Hospital of Chiari (Brescia), Italy

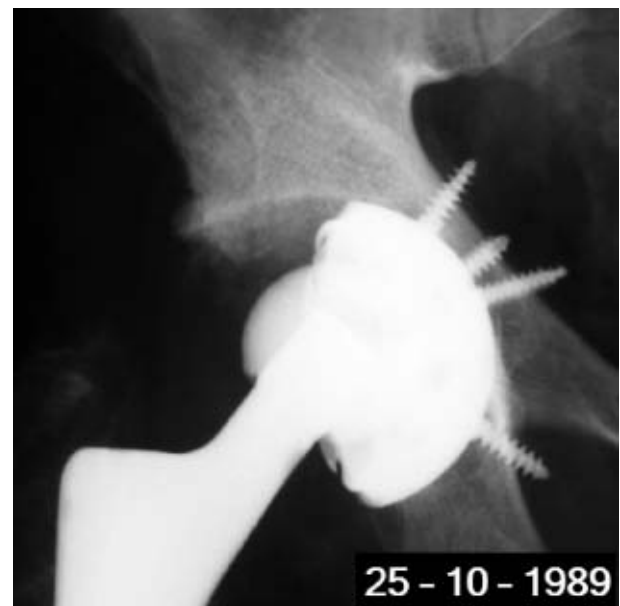
Figure 1. The unsuccessfully positioned uncemented prosthetic cup. The cephalad rotation of its lateral border is observed (verticalization of the prosthetic cup)

of the neck of the right femur in November 1988, which was treated with a blade-plate with 1 hole and 2 long spongiosa screws with washers. He underwent a total right hip prosthesis in 1989 following the failure of this treatment. The lateral border of the prosthetic cup, a cementless model with screws, was initially unsuccessfully positioned with cephalad rotation of its lateral edge (Fig. 1). After 4 years, in 1993, the patient attended the Orthopaedics and Traumatology Division of the Civil Hospital of Chiari (Brescia, Italy) complaining of a serious functional impotence and severe pain on every attempt to move and to bear weight on the right hip. The cup therefore underwent a revision procedure carried out using a modified Watson-Jones approach. This revealed that the ceramic head was broken in several parts and a pseudo-acetabulum located above the prosthetic acetabulum was formed by the grinding action of the dislocated head. The polyethylene liner was removed and the screws were removed from the acetabular bed. Following unsuccessful attempts to remove the cup, whose stability was considerable, it was left in place and a new polyethylene cup and a new prosthetic head were positioned (Fig. 2). The polyethylene cup was subsequent-

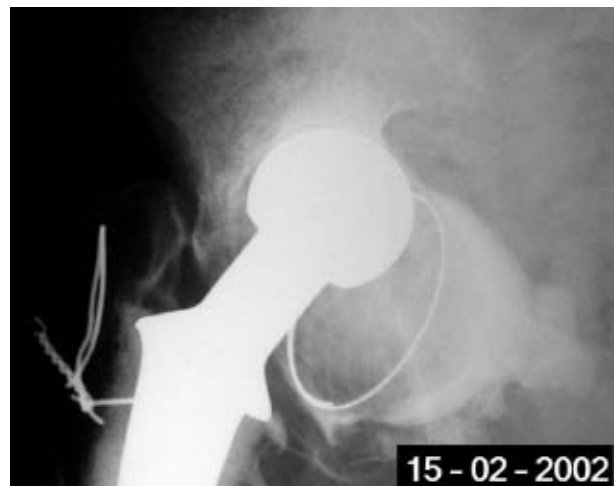
Figure 4. Cephalad rotation with inferior migration of the cemented polyethylene cup (verticalization of the prosthetic cup) and dislocation of the femoral prosthetic head. The presence of a pseudo-acetabulum produced by the grinding action of the metal head on the acetabular roof is observed

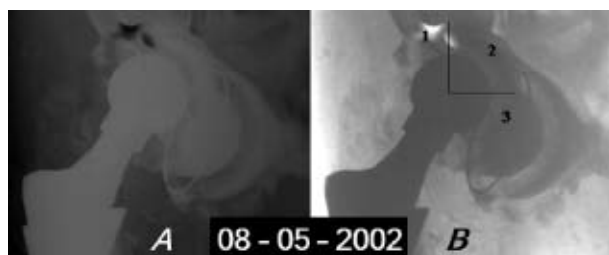
Figure 5. Revision of the cemented polyethylene cup using the “Wall-Socket” method and replacement of the femoral stem (A). The presence of a new cemented polyethylene cup is shown. The same figure in negative (B) reveals the presence of the previous cup in DeLee and Charnley’s zone 3

cup and the prosthetic stem underwent revision using the Hardinge-McFarland-Osborne approach. Considering the possible risks that cup removal could involve and given its stability, the surgeon decided to leave it in place and to position a second cemented polyethylene cup beside it (Fig. 5). A radiological control carried out 3 years after surgery (follow-up of more than 3 years) revealed that the new cup had remained in place with no manifest signs of mobilisation or radiolucency (Fig. 6). Since July 2007 the patient, aged 88 yrs., loads the joint freely without pain.

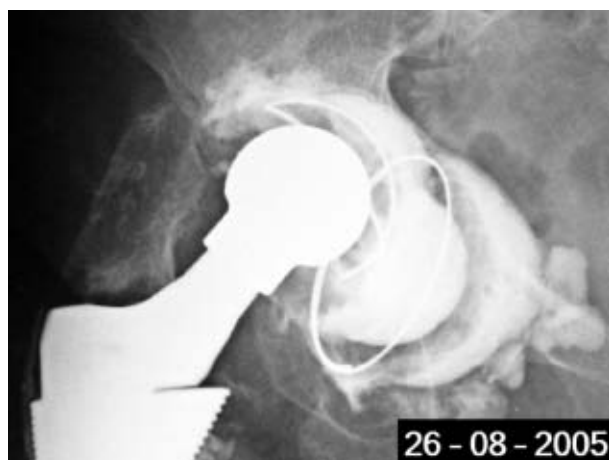
Figure 6. The radiographic follow-up 3 years after the revision procedure with the “Wall-Socket” method. The good stability of the new acetabular component is pointed out
